## Failure and Reconstruction of a Waste Containment Pond Slope

**SYNOPSIS:** A portion of a slope of a subsurface waste containment cell failed. It is believed that this failure could be attributed to a sudden drawdown condition caused by the pumping of treated wastewater effluent stored inside the cell prior to construction of the permanent liner. This conclusion seems to be in agreement with the results of a stability analysis conducted utilizing post-failure slope profile data. A discussion of the analysis of the failure and the reconstruction of the slope is presented in this paper.

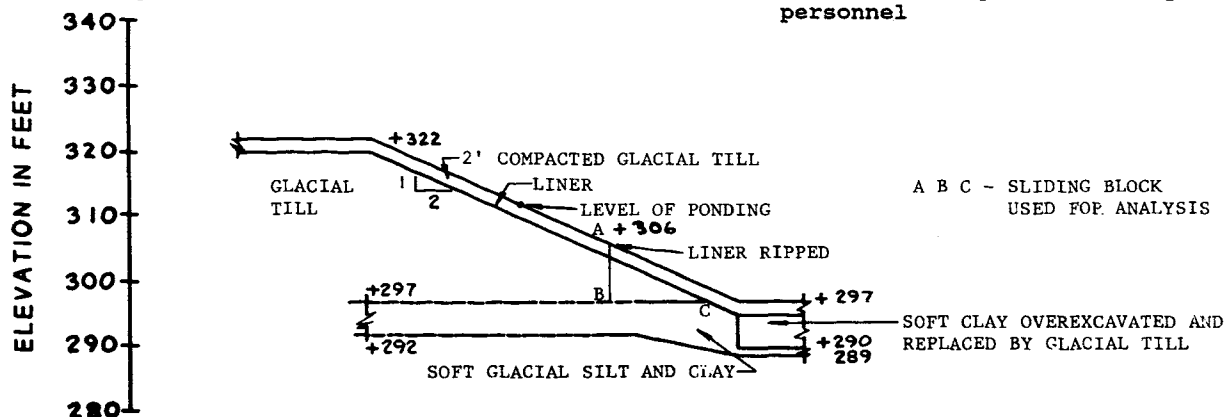
**FIGURE 1- CROSS SECTION OF NORTH SLOPE**

The waste containment cell referred to in this paper is located somewhere in the northeastern United States. The purpose of this earthen containment is to store hazardous solid wastes. Figure 1 shows a typical cross section of this structure. The bottom and the sides of the containment cell are lined with a 2 foot thick soil liner consisting of compacted glacial till (clay), and a 10 mil thick impervious membrane liner.

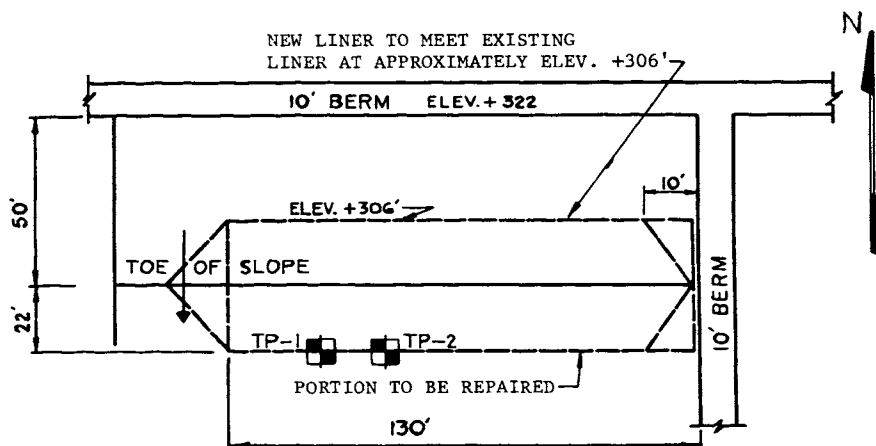
FIGURE 2- PLAN VIEW OF THE CENTRAL PORTION OF THE NORTH SLOPE SHOWING CONDITIONS AND THE EXTENT OF REMEDIAL WORK TO BE DONE.

These consisted of several site visits to the site by the authors, surveyors and other technical personnel. Figure 2 shows the details of conditions observed. Two test pits and several hand-excavated holes were excavated in the vicinity of failure to observe the soils and expose the liner. Soil samples from the liner materials and underlying natural soils were obtained for testing. Some undisturbed tube samples of soft clay were obtained from locations in the vicinity of failure. At selected stations along the north-central slope, survey cross sections of the slope were obtained. A typical post-failure slope profile is shown in Figure 3.

1. The soil above and 6 inches below the membrane liner was saturated.
2. The membrane liner separated along a seam near the top of the slope approximately in an east-west direction and no rips were noted near the top of the slope.
3. The membrane liner was ripped at an elevation approximately 8 to 10 feet above the bottom of the landfill cell.
4. The bottom of the cell adjacent to the toe of the slope heaved to a distance of 15 feet horizontally from the initial toe of slope.
5. In the region near the bottom of the cell, the underlying natural clays heaved up over the compacted glacial till liner soils.
6. The slope moved horizontally in the region between the elevation where the membrane liner ripped and the bottom of the containment cell slope.

3. Each lift of fill should be compacted to at least 90% of its maximum dry density (ASTM D-1557).
4. The compacted glacial till should be placed within the limits shown on Figure 2 to the slope configuration shown on Figure 5.
